The Salvage of the "S-51"

A Feat of Engineering Without Precedent in Naval Records

By Edward Ellsberg, Lieut.-Commander, Construction Corps, U. S. N.

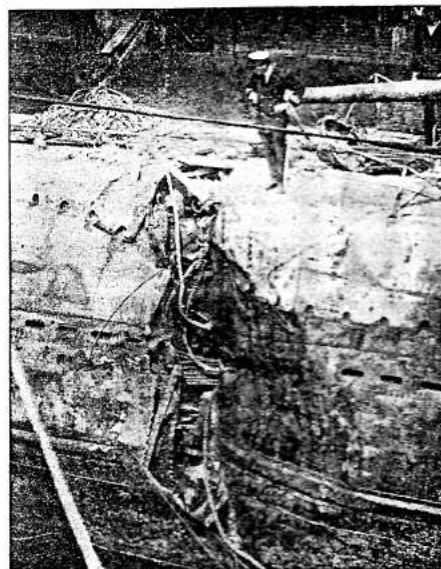
She was sunk at 10:24 P.M., September 25, 1925. At that time she was operating as a surface vessel, course about northwest, speed 11.5 knots. She was struck 30 feet forward of the conning tower on the port side by the *City of Rome*, the angle of impact being 40 degrees abaft the port beam (actually measured in drydock from trace of stem and forefoot of the *City of Rome* in the S-51's side). A hole 13 feet deep and 2½ feet wide was made at frame 54, coming about the middle of the battery room, which is the main living compartment.

THE FATAL WOUND
In this photograph is shown the port side of the S-51, from about the angle at which the *City of Rome* overtook and cut her down. The swift rush of water doomed the ship

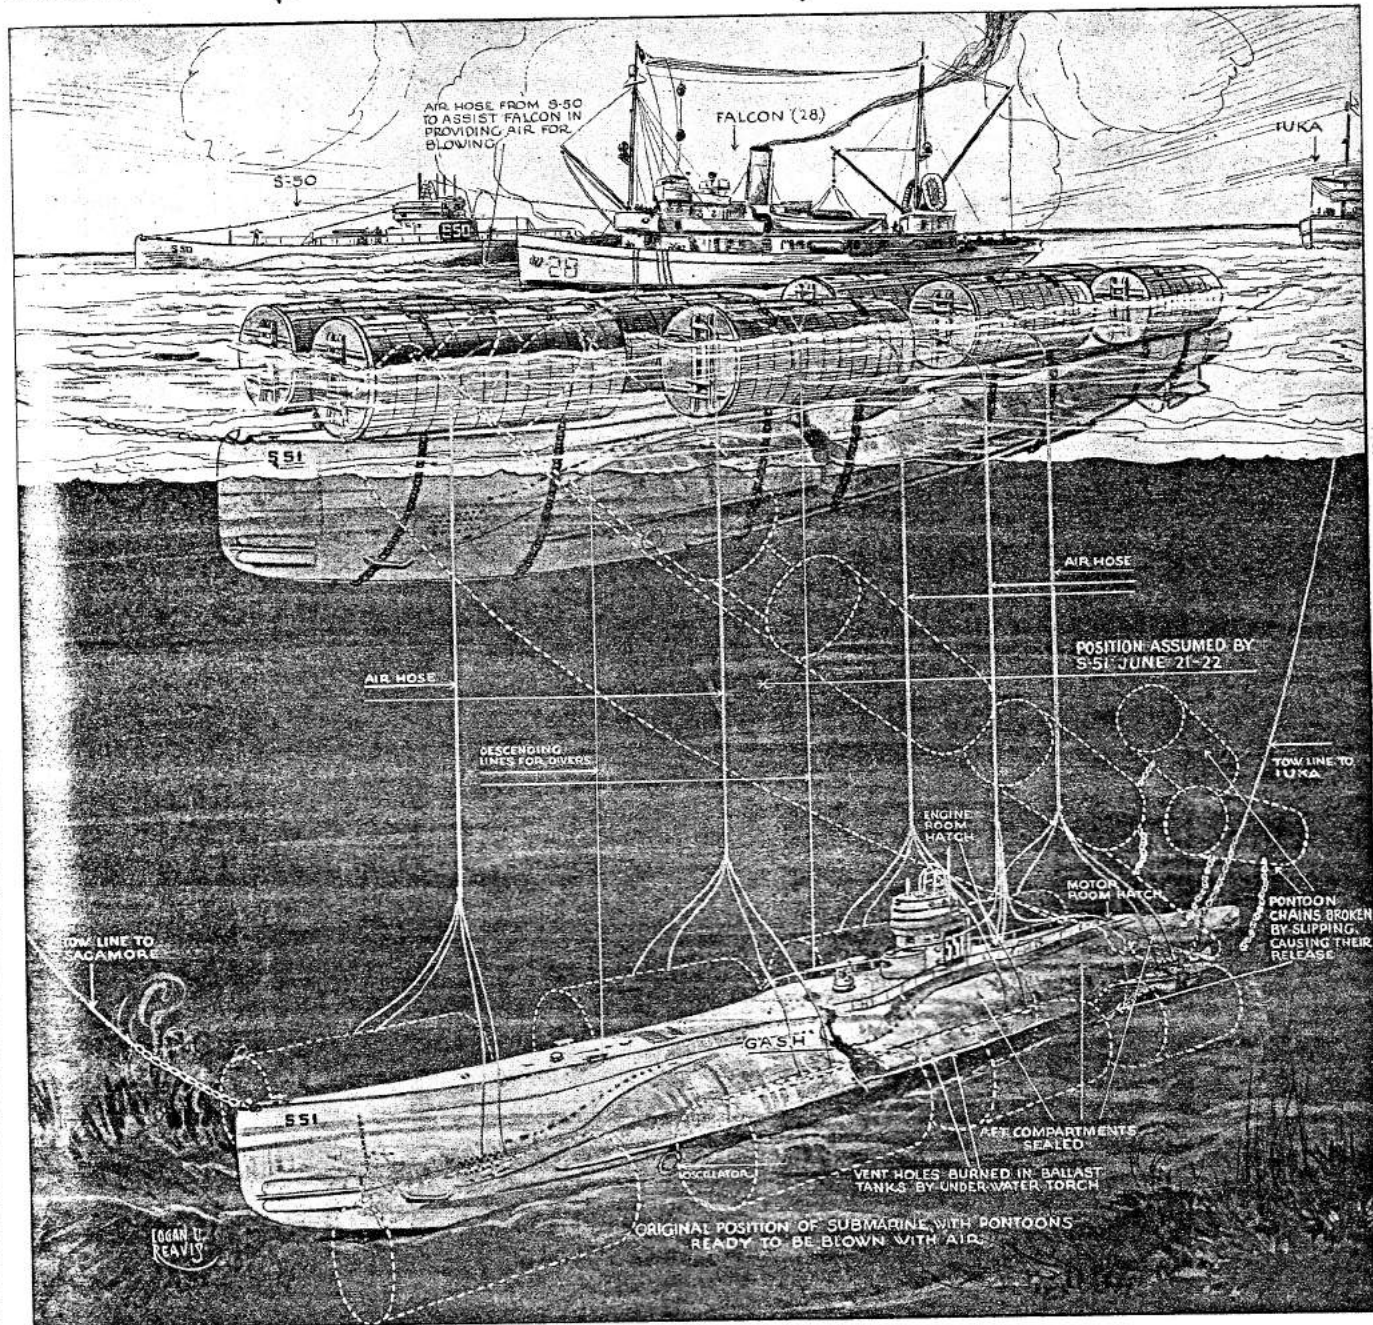
HOW THE NAVY PERFORMED ITS GREATEST FEAT OF SALVAGE

The S-51, weighing 1,200 tons, lay on the bottom in 132 feet of water, 14 miles from the nearest land and in very exposed and rough waters. Because of the gash in her side, the forward half of the boat could not be sealed. The after half was sealed and the water blown out. Eight pontoons, each with an 80-ton lift, brought the boat to the surface

To provide the remainder of the buoyancy required, as well as a margin for contingencies and a reserve, eight pontoons were provided, each with a net lift of 80 tons. These pontoons were steel cylinders, 32 feet long, 13 feet in diameter, sheathed outside with four-inch yellow pine planks. Each pontoon was built like a section of a submarine, and was suitably stiffened with frames and girders, being designed to resist the full internal bursting pressure in case of a sudden rise to the surface. Through the vertical center of each compartment was run a 12-inch hawsepipe, riveted to a heavy casting, top and bottom, with eight internal brackets to distribute the load from the hawsepipe castings to the pontoon itself. Two and one-half inch anchor chain, threaded through these hawsepipes, formed the cradle for the boat.
