Marine Engineering and Shipping Age

Structural Damage Sustained by S. S. Majestic

Failure of deck plating indicates importance of careful design and arrangement of strength members of hull structure

By Edward Ellsberg*

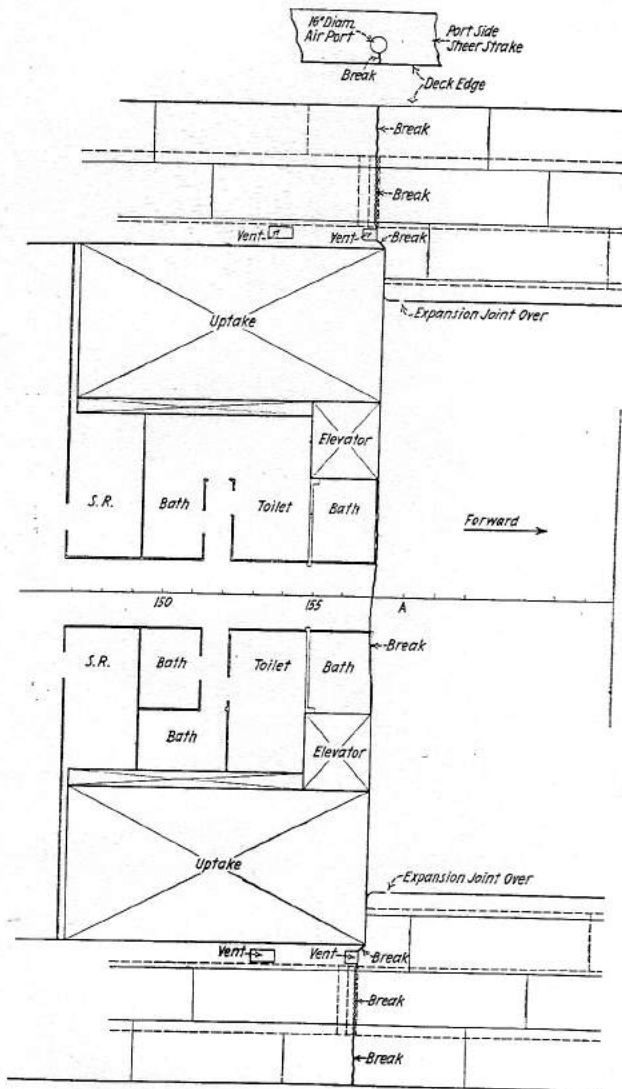
At the forward outboard corner of each uptake hatch, the plating of the deck was cut out on a right angle. There was no compensation fitted around the corners of the opening. Just outboard of the uptake corner, and about 8 inches from it, another rectangular hole about 12 inches by 20 inches was cut through the deck stringer for a ventilator trunk. Just outboard of this ventilator was a butt in the adjoining strake of the deck plating, with its consequent close rivet spacing. About 18 inches forward of the uptake was an expansion joint in the superstructure, which commenced just above the *C* deck. Underneath the *C* deck, and in line with the edge of the uptake, was a girder which ended with a small bracketed connection to the uptake plating. Inboard of the uptake openings were the elevator shafts as already pointed out.

All the above factors produced a most obvious line of weakness, which happened to come right on the midship section. In addition, failure to compensate the heavy deck for the openings cut in it, especially at the forward outboard corners, resulted in concentrating at these sharp corners all the strain carried from forward by a much wider strake of heavy plating.

Due to this local strain, it is evident that the cracking first started at the square corners. From this point, the cracks ran outboard a short distance into the ventilator hole. From here the cracks continued outboard, along the line of closely spaced rivets in the buttstrap, to the 2-inch deck stringer, through which they ran to the sheer strakes and

It will be seen that in this case, the damage followed the weakest section. Considering the structure and the nature of the fracture, it is clear that the fracture was progressive. From the port and starboard uptake corners the cracks

Plan of section of C deck, showing location of break

worked their way outboard rivet by rivet until enough of the deck was gone on both sides to make the light inboard plating take part of the strain. This light plating then let go, which damage was soon discovered, as in this location there is a central passage over this spot and the interior deck covering would crack with the deck. This was the condition in the summer of 1924.

The progressive rupture of the C deck continued through the fall, and when in December the vessel was finally exposed to heavy weather, there was so little of the top flange left that, under a real strain, the remaining metal let go with a bang. It is safe to assume that at this instant the vessel was rolled to the starboard side, so that the port sheer strake was also acting as part of the top flange and

In repairing the damage, care was taken to insure its non-recurrence. All fractured plates were of course replaced. The initial error was corrected by making the new plating around the uptake corners half an inch thicker than the adjacent deck plating. In addition, the ventilator opening near the corner was eliminated, the buttstrap outboard of the corner was moved several frames away and the girder underneath the deck was more securely fastened to the uptake bulkhead. The effect of all this was to eliminate the line of relative weakness and to reinforce the corner against local strain. Finally, in renewing the fractured deck plate inboard between the elevator shafts, the thickness was increased from $\frac{5}{8}$ inch by laying a new doubling, several hundred feet long, over this section. This, however, appears a useless precaution. As there are no inboard longitudinal bulkheads to connect this plating to, it can never take a strain until the outboard sections of the deck, which, due to their connections to the shell, act as the flanges, give way. As means to prevent such a mishap to the outboard plating have been provided, the strengthening of the deck inboard was unnecessary, resulting only in needless expense and addition of weight.
